# **Formerly Utilized MED/AEC Sites Remedial Action Program**

**Removal of a Contaminated Industrial Waste Line,  
Los Alamos, New Mexico**

**April 1979**

**Final Report**

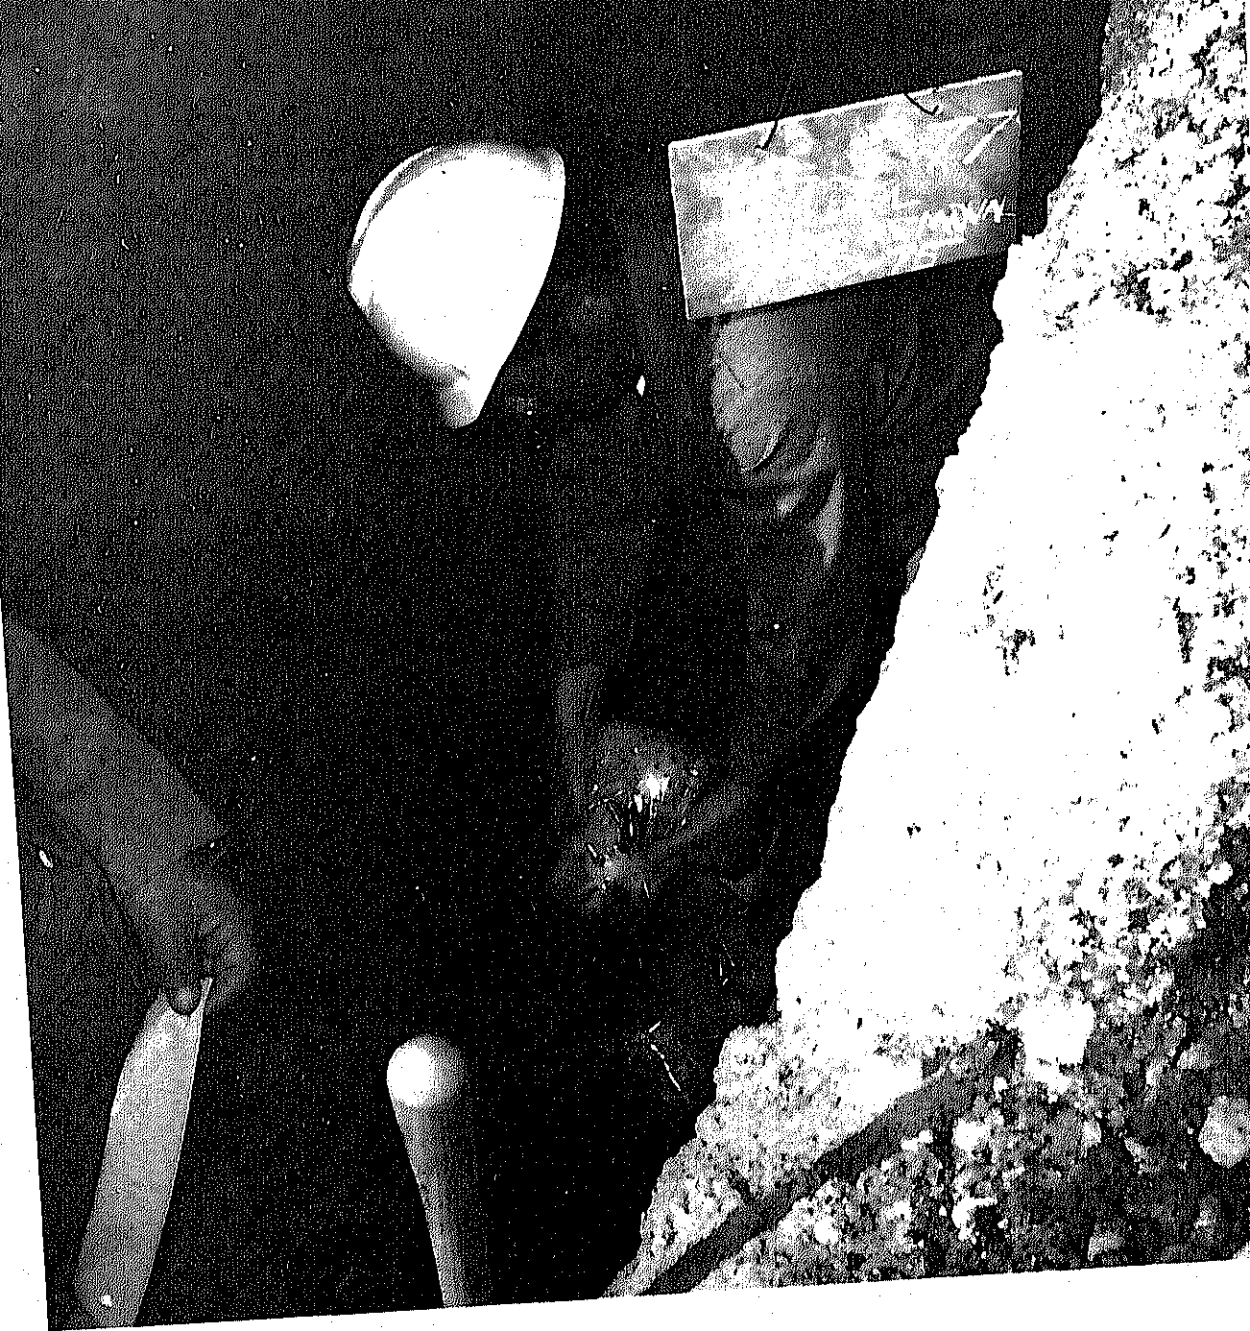
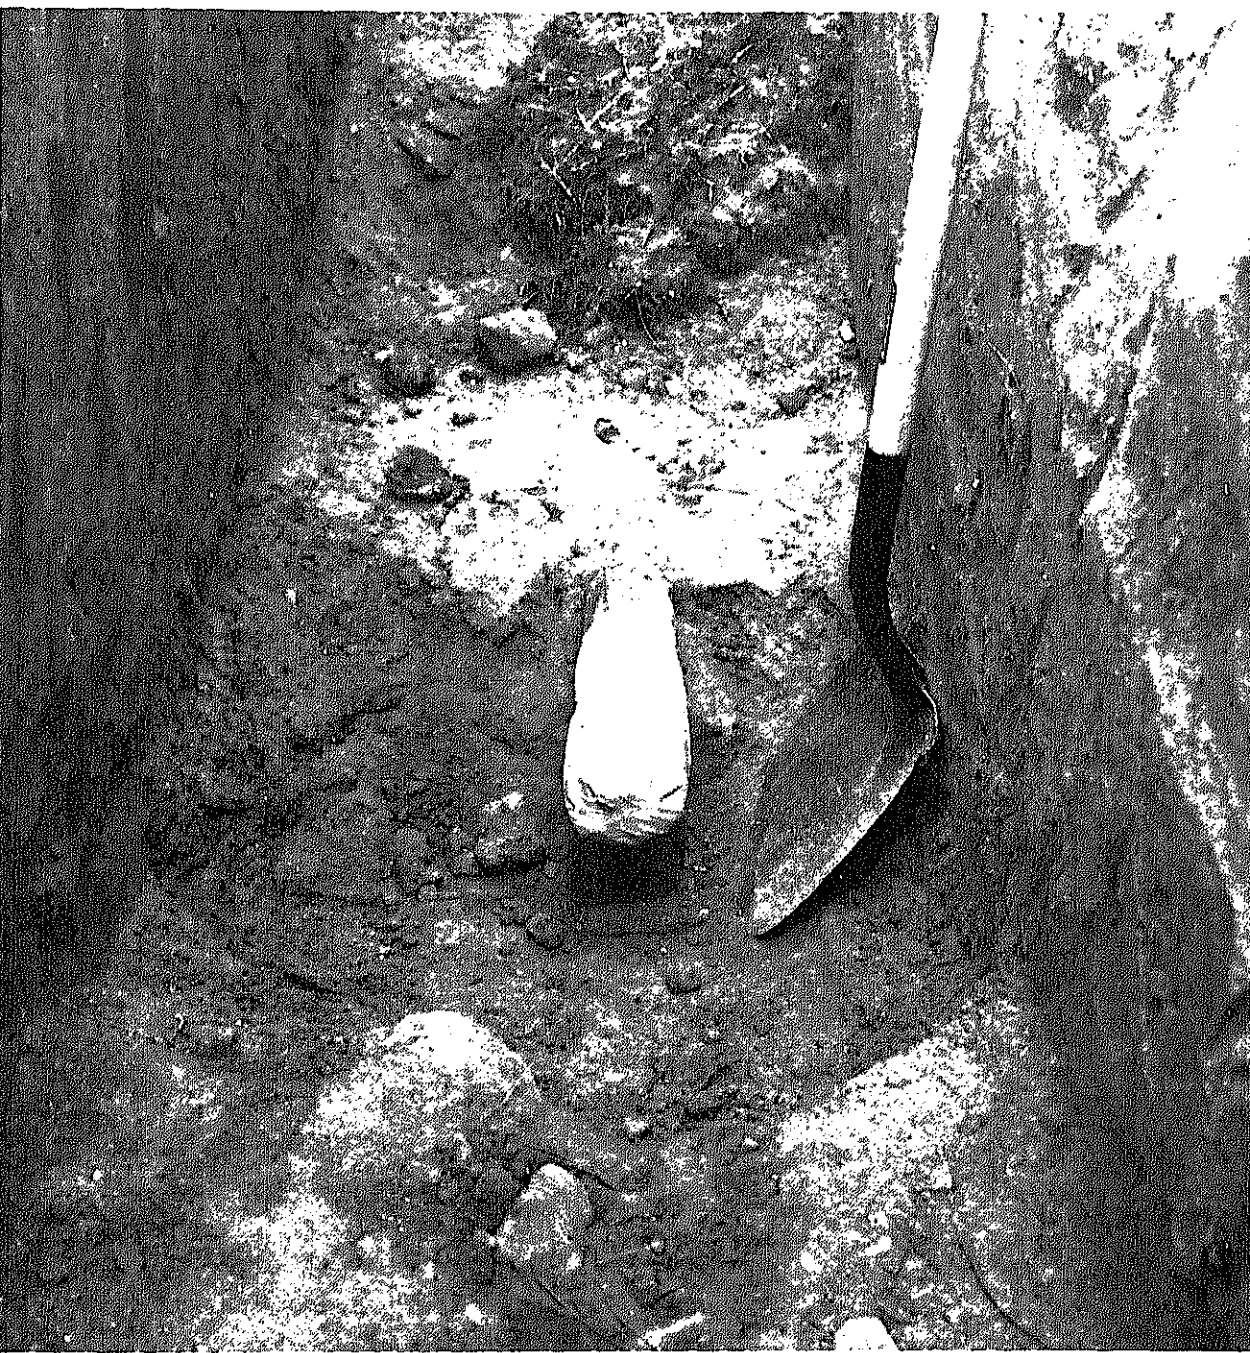
Fig. 8.  
*Ends of cut IWL are sealed with plastic bags and adhesive tape.*

and adhesive tape (Figs. 8-9).

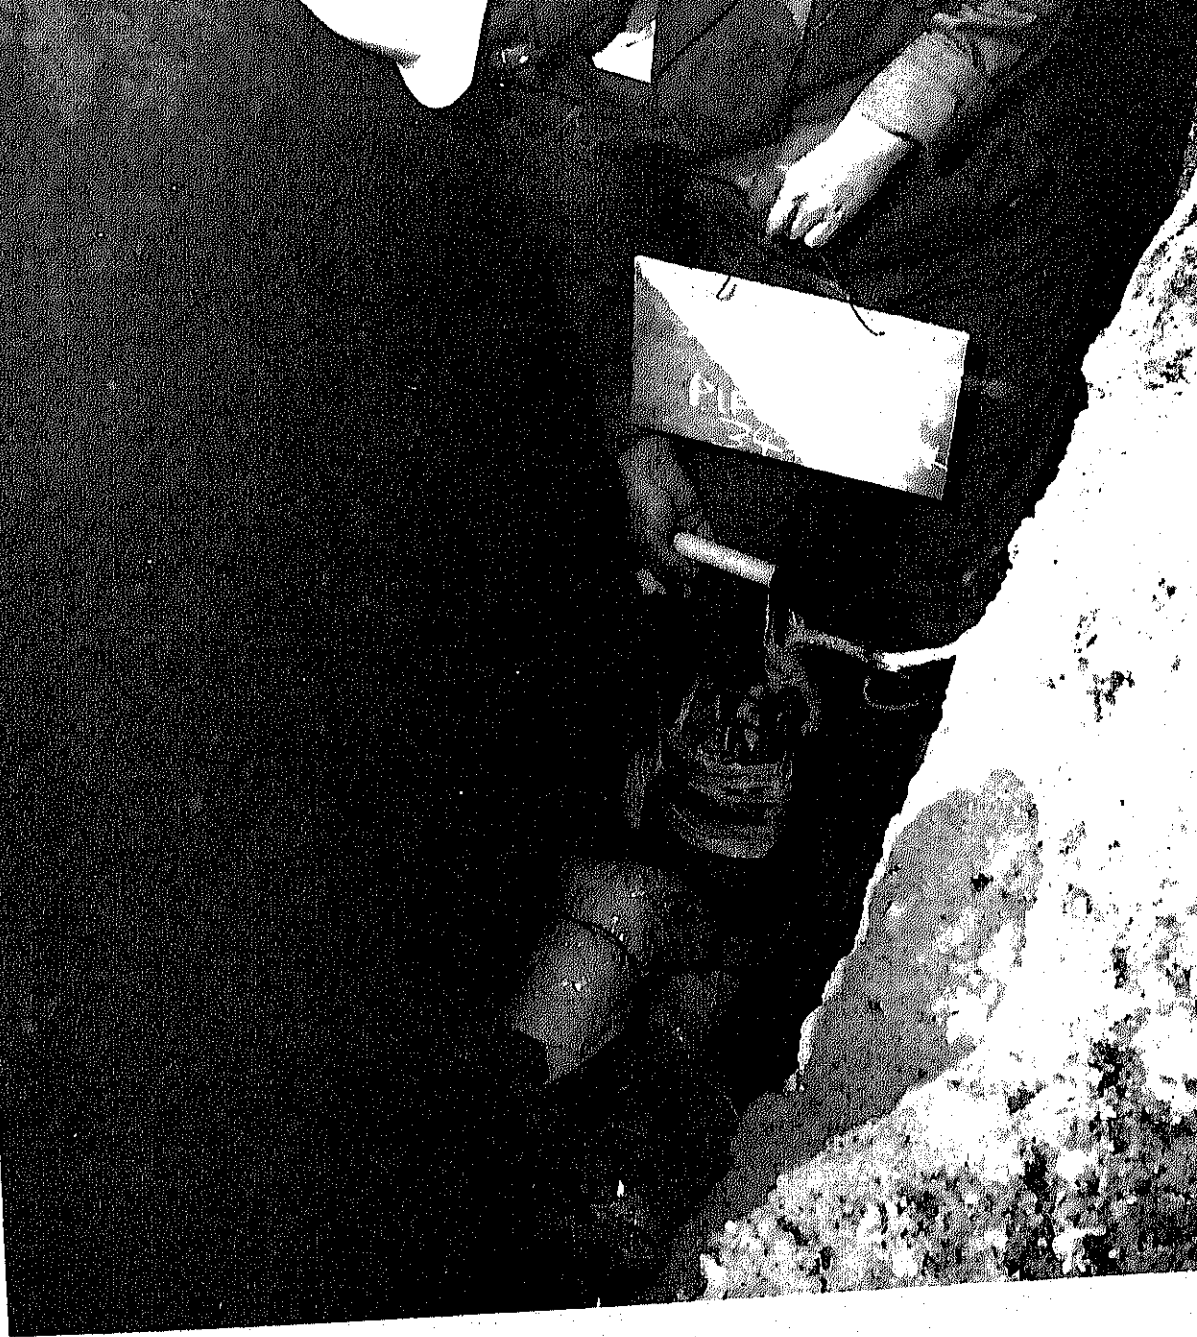
*Fig. 10.  
Sealed IWL is monitored with a phoswich to determine if any activity is on the pipe's exterior.*

Any soil wetted with liquid from the pipe was sent in sealed plastic bags to the radioactive waste disposal site. Monitoring of the sealed pipe with a phoswich determined if any activity were on the pipe's exterior (Fig. 10). A soil sample was collected under the cut (Fig. 11). Each joint underwent visual inspection and monitoring to determine if any leaks had occurred in the past. The pipe section was then removed from the trench (Fig. 12) and placed into dump trucks for shipment to the disposal site. The dump truck beds were lined with plastic (Fig. 13) and a custom-made tarpaulin covered the load while in transit to the waste disposal area (Fig. 14). The trucks were monitored before returning for their next load to ensure against carrying contaminated material from the disposal area.

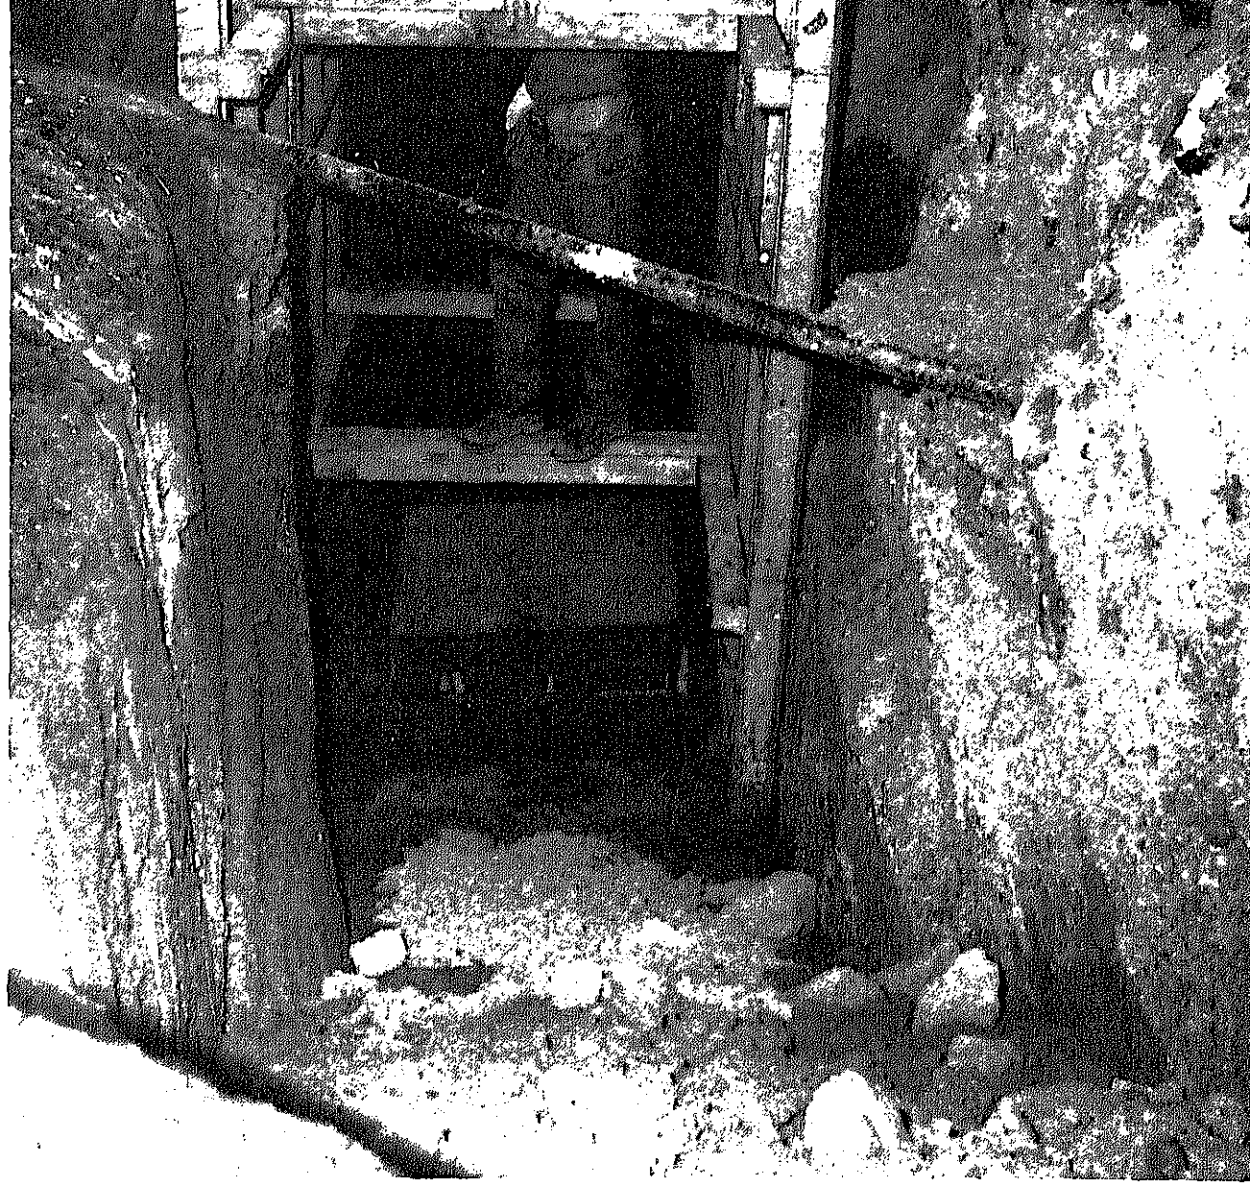
*Fig. 16.*  
*Shoring system used throughout the project.*

**a. Excavation Collapse.** Since excavations were entirely in previously excavated soil with indeterminate grades of backfill, shoring in accordance with the Occupational Health and Safety Administration regulations<sup>6</sup> was required during the entire project. The Zia Company (the LASL support contractor) devised a shoring system used throughout the project (Fig. 16). The shoring proved itself on May 11, 1977, when a section of the soil, weighing about 1000 kg, collapsed and

was restrained by the shoring. Three workers were in the trench at that time, but none were hurt. In several places, it was advantageous to remove about a meter of soil prior to trenching to eliminate or reduce the need for shoring. A backhoe removed pipe directly along the deepest section of the trench, eliminating the need for personnel entry into the trench.

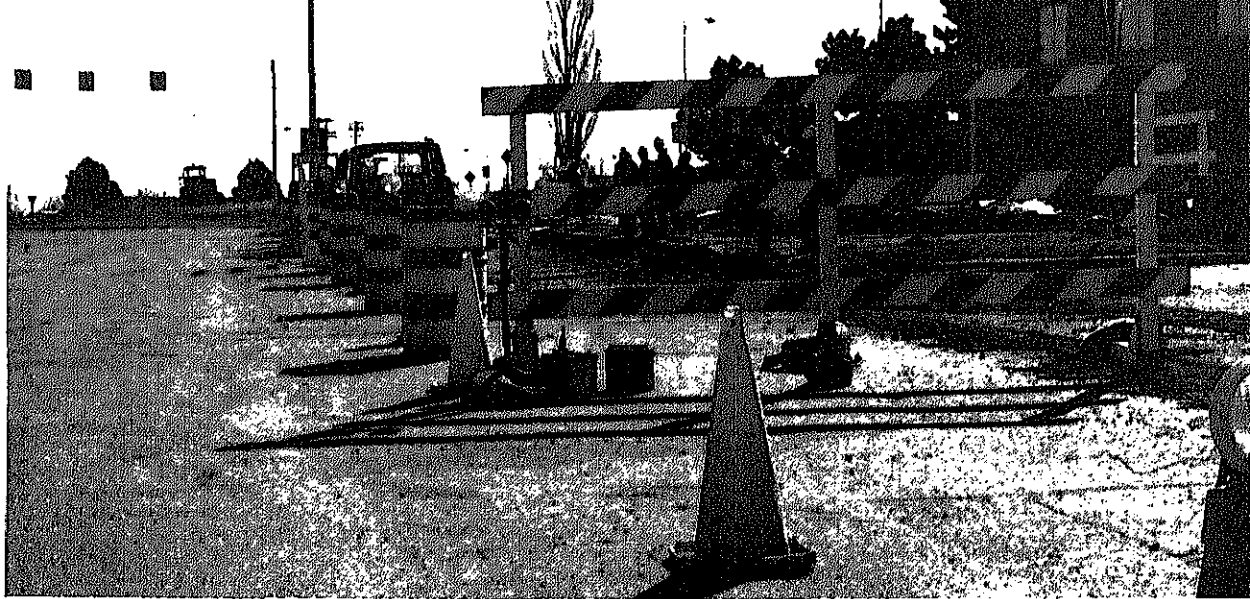
*Fig. 17.*

**b. Traffic Control.** Traffic control plans developed and implemented for several phases of the project included barricades, signs, and flagmen to assist trucks in entering and exiting the construction area (Fig. 17). Two minor accidents occurred. The first involved an intoxicated driver driving an auto into one of the barricades. The second happened inside the construction zone and occurred when an unattended private vehicle rolled into a parked government vehicle. There were no injuries in either accident.

*Traffic control barricades assist trucks in entering and exiting the construction area.*

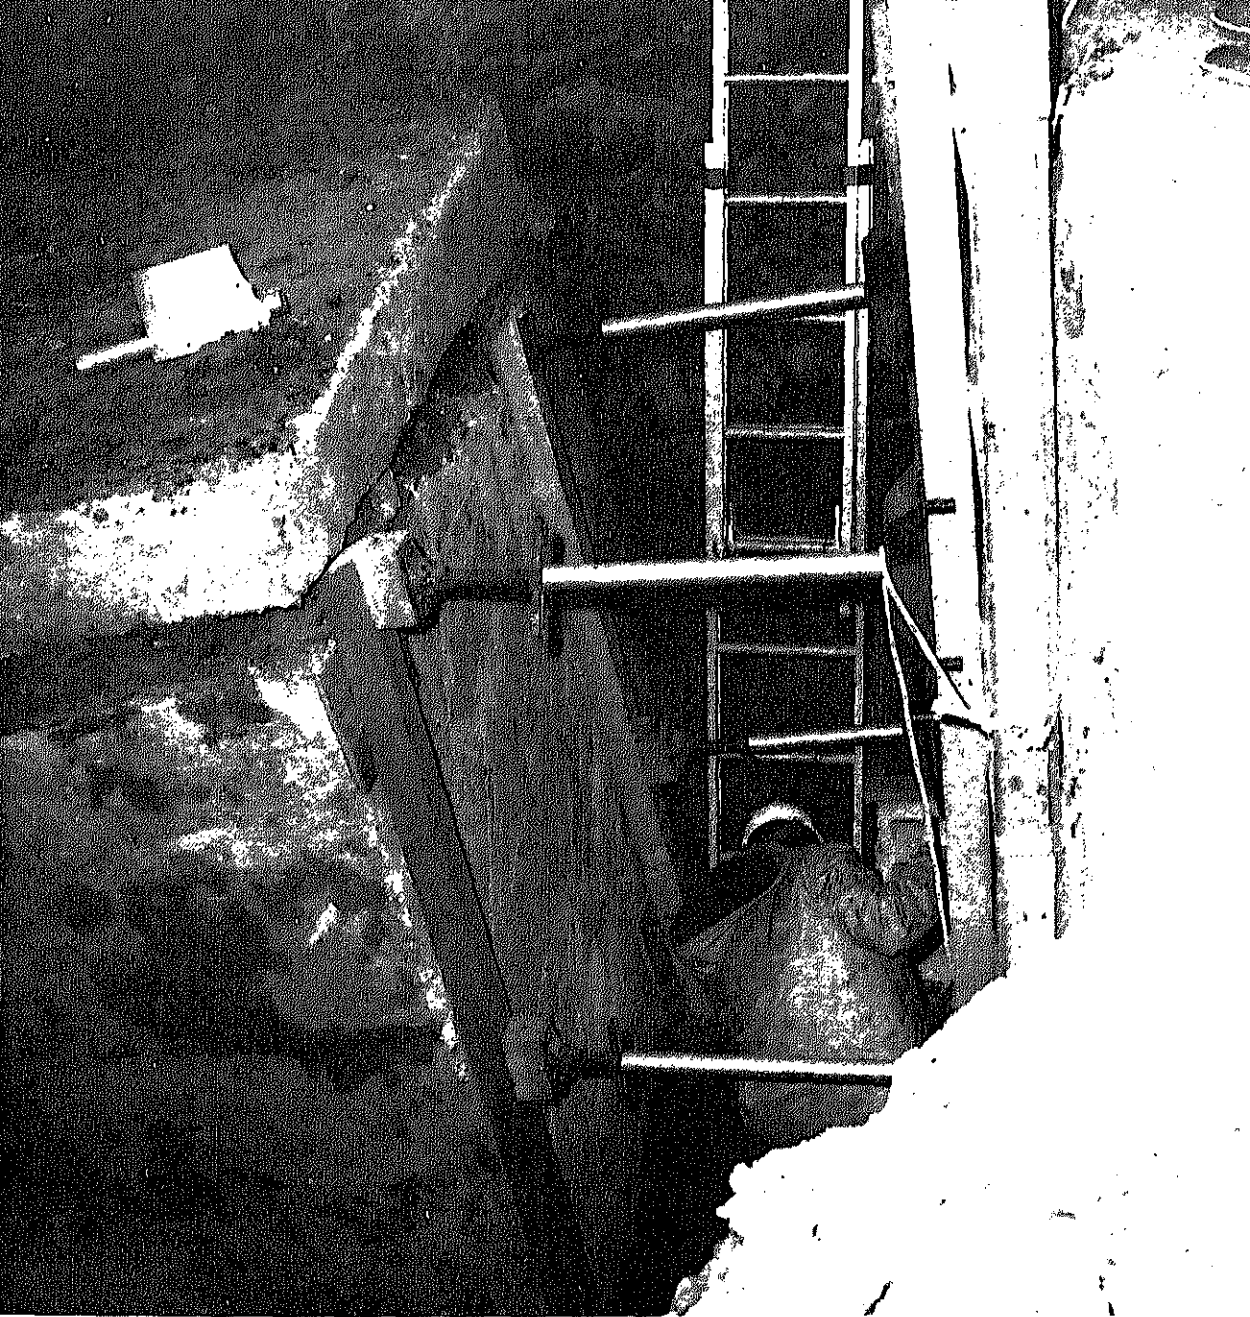
*Fig. 20.*  
*Excavation at manhole ULR-35.*

this structure on this project (Figs. 20 and 21), contamination >100 000 counts/min on the phoswich and 5000 counts/min gross alpha on a survey meter were found in the soil on the northern and southern sides at the level of the inlet and outlet ports. The contamination originated from inadequately sealed ports (Fig. 22). A sample near the port that had 1400 pCi/g of gross-alpha activity on the ZnS system, was analyzed radiochemically and the isotopes identified were  $^{239}\text{Pu}$  ( $20 \pm 1$  pCi/g),  $^{238}\text{Pu}$  ( $760 \pm 30$  pCi/g),  $^{241}\text{Am}$  ( $200 \pm 4$  pCi/g),  $^{137}\text{Cs}$  ( $50 \pm 3$  pCi/g),  $^{60}\text{Co}$ , and  $^{235}\text{U}$ . Holes were drilled into the top of inlet and outlet pipes prior to cutting the pipes to determine if liquid was present. There was none. The manhole was removed and taken to the waste disposal area (Figs. 23 and 24) and the excavation decontaminated to as low as practicable.

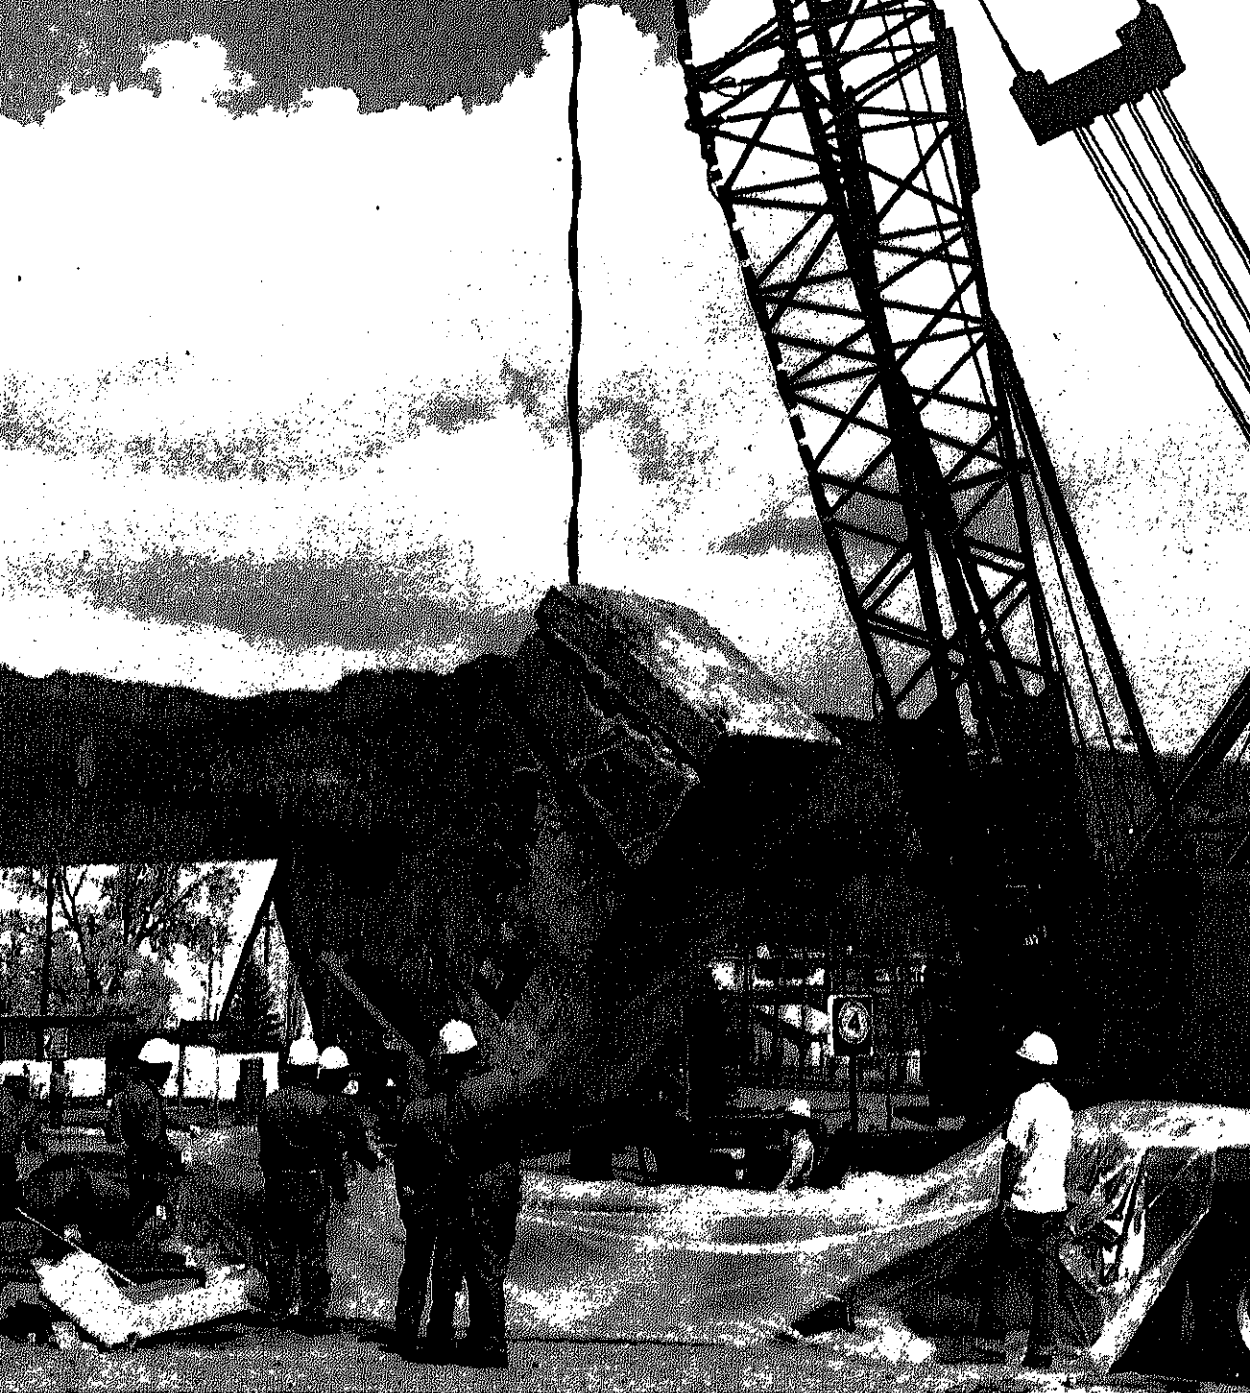
Fig. 23.  
*Manhole ULR-35 is loaded on a lowboy trailer.*

*Fig. 24.*  
*Manhole ULR-35 is secured on a lowboy trailer.*

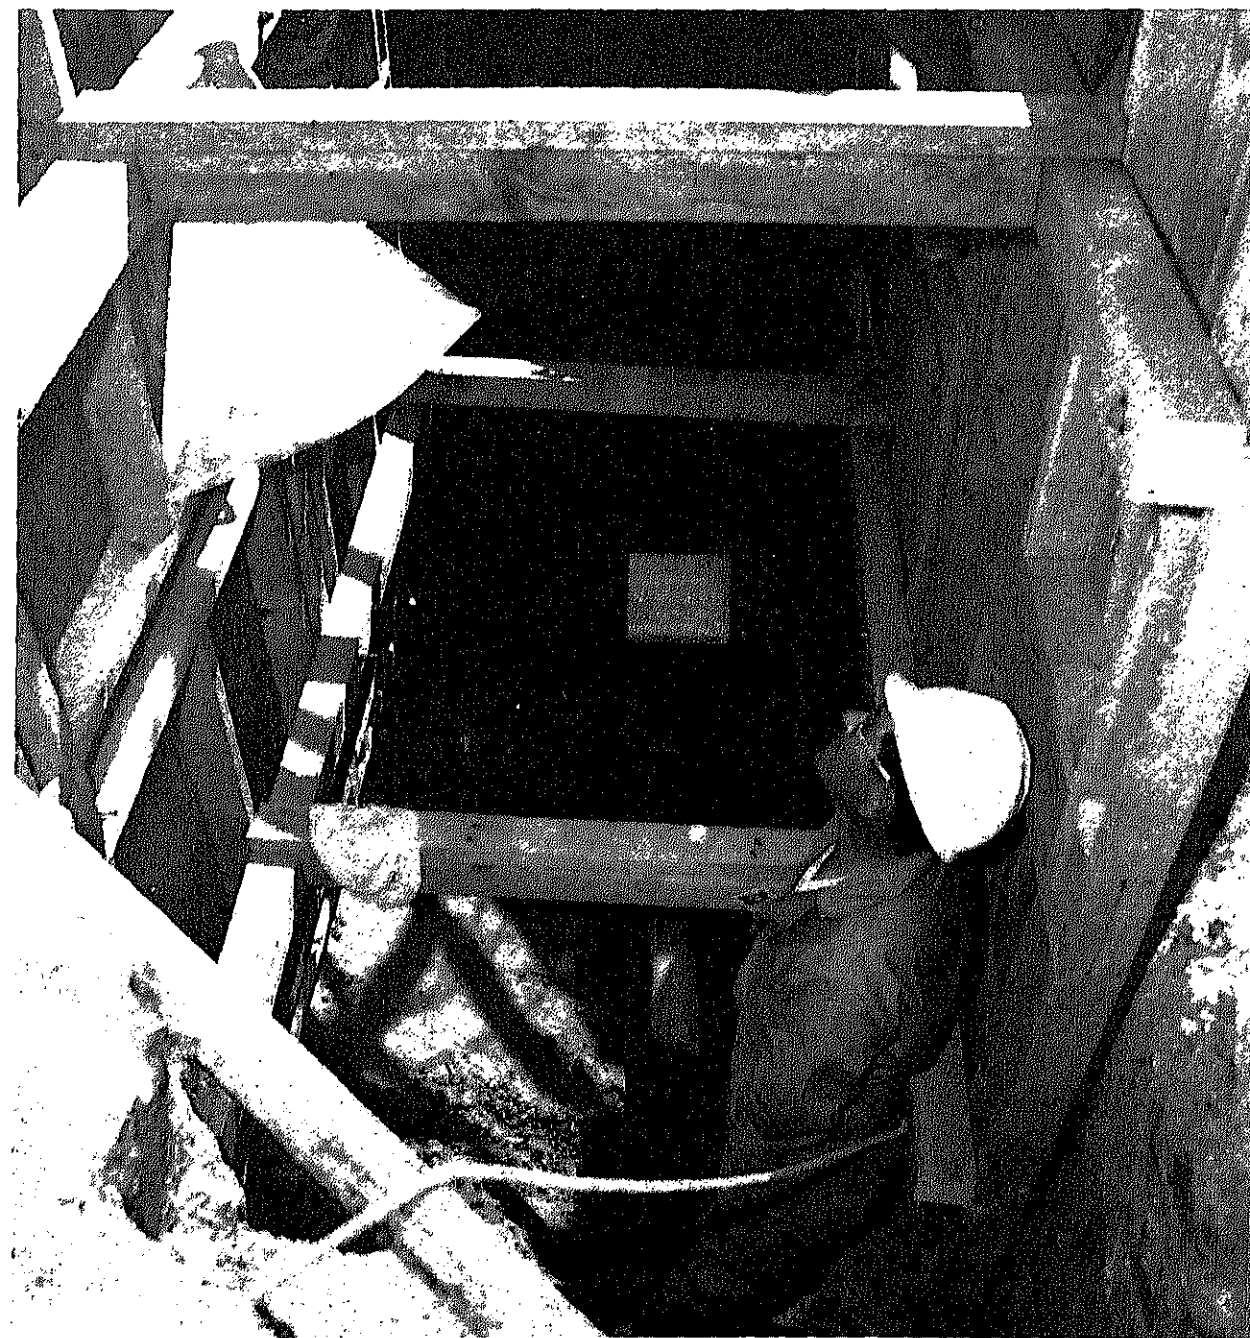
The outlet pipe exiting ULR-35 ran north through a 30-cm diam casing under Trinity Drive (Fig. 25). The pipe was found with a loose concrete seal over its end at 40+00. Some gross-alpha contamination ( $\sim 1300$  pCi/g) was found on the northern edge of the casing. Soil was removed until the area was decontaminated to  $\leq 25$  pCi/g of gross-alpha activity. The pipe running through the casing was removed and the casing cleaned out (Fig. 26). Dust problems during cleaning were eliminated by filtration of the casing air through a high efficiency particulate filter. A thin layer ( $< 5$  mm thick) of rust too difficult to remove was left in the middle of the casing. A gross-alpha count of the rust was 300 pCi/60 cm<sup>2</sup>. This condition was determined to be as low as practicable so the casing was grouted with concrete and left in place.

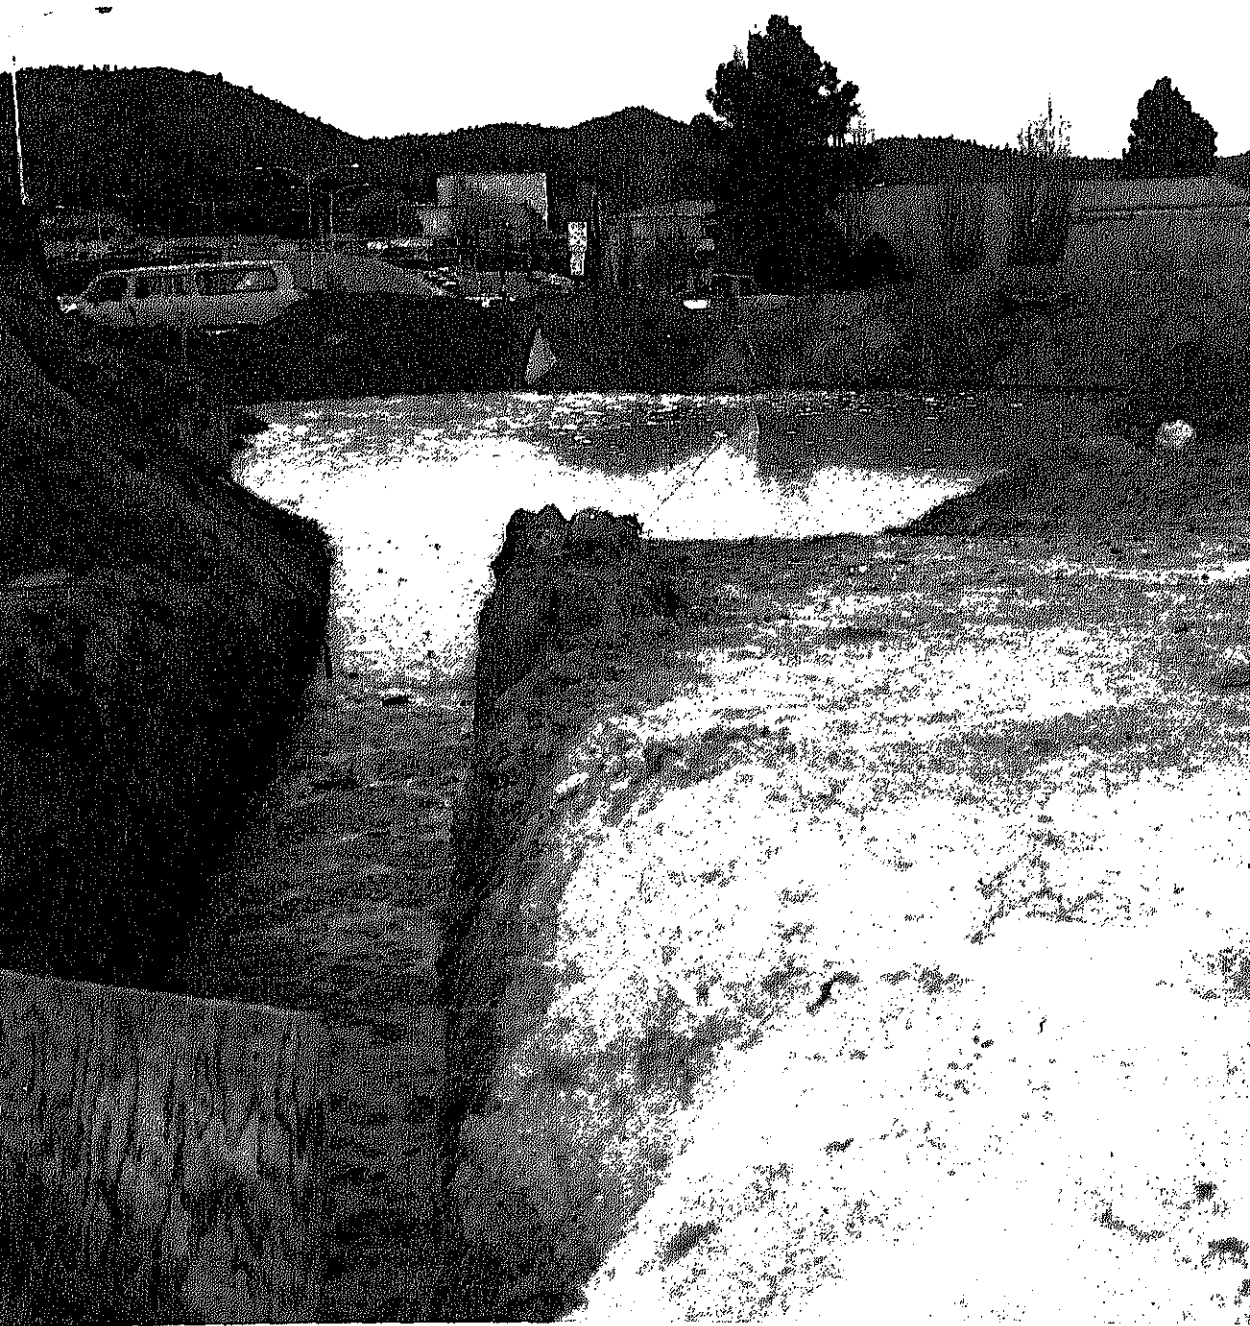
*Fig. 27.*

A domestic water line, between ULR-35 and ULR-60, located approximately 7 m above the clay pipe, was accidentally ruptured during this excavation. The water released was impounded (Fig. 27) and sampled for the presence of radioactivity. None was detected. The uncontaminated water was then pumped into nearby Los Alamos Canyon. After the water was removed, mud samples were collected and the absence of gross-alpha activity was confirmed. The trench was backfilled with pulverized tuff to absorb moisture. This material was then reexcavated and sent to the disposal area to permit resampling of the trench. No gross-alpha activity was detected at any time.

*A domestic water line, between manhole III R-35 and III R-60, is accidentally ruptured dur*

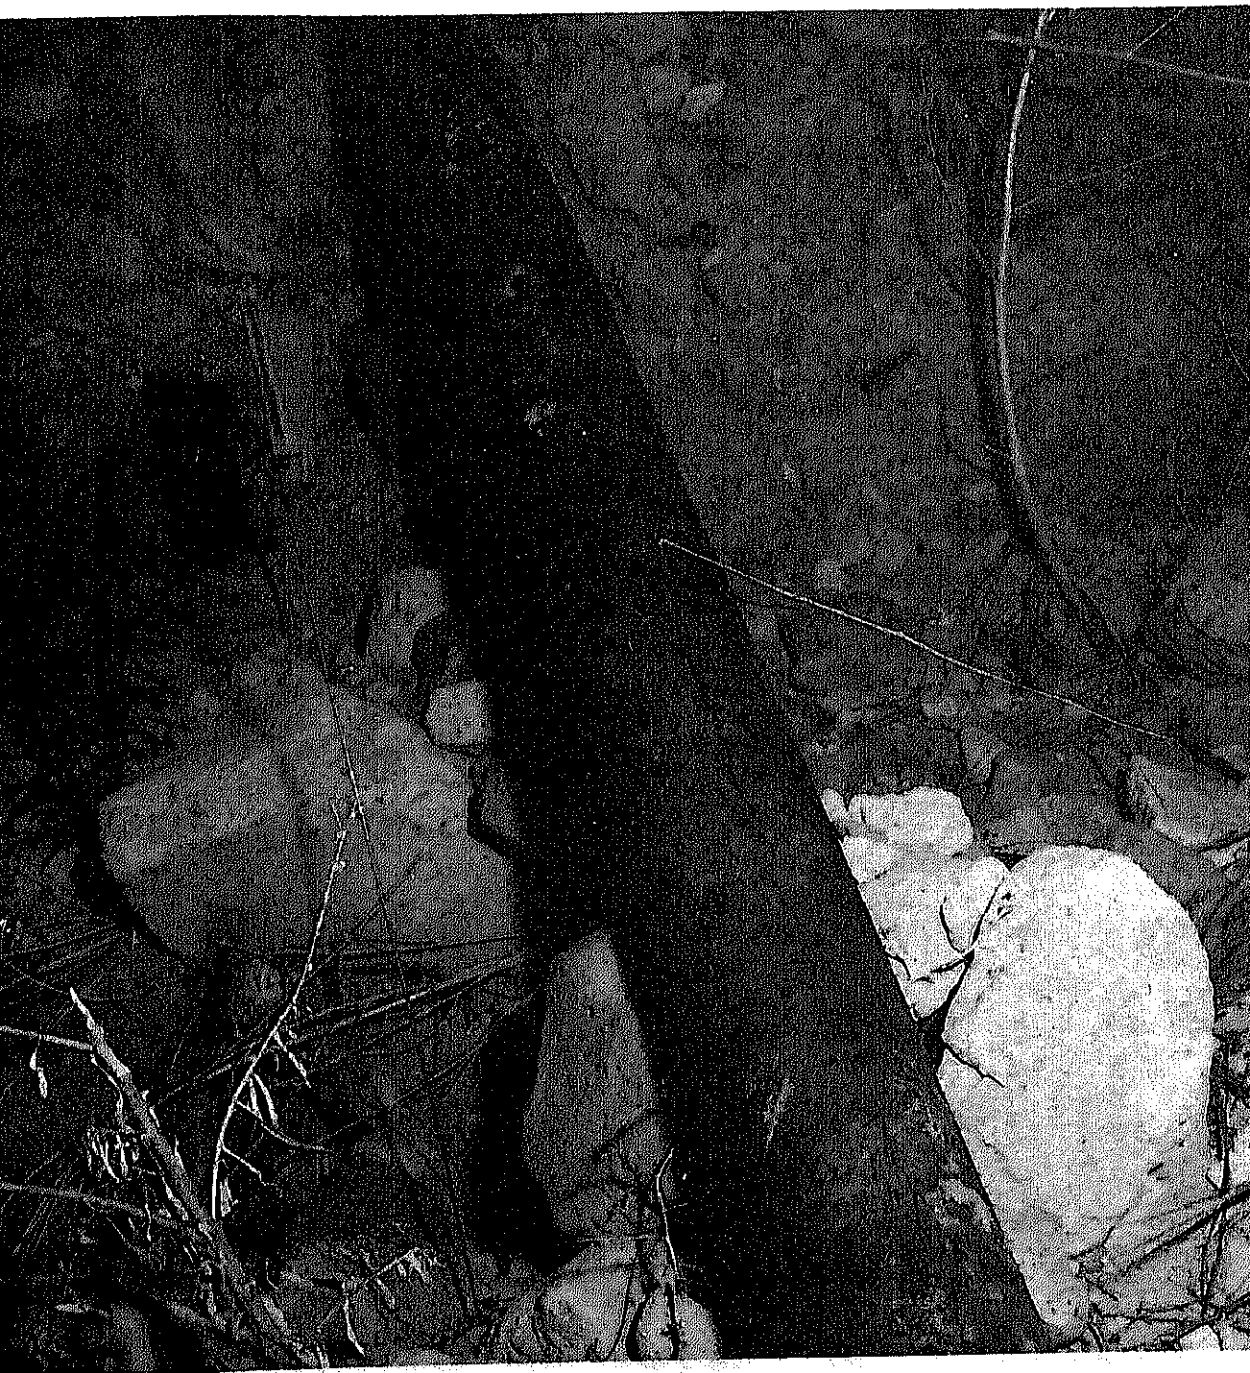
*Fig. 29.*

contamination of 49 pCi/g was found under one crack; the area was decontaminated to  $\leq 25$  pCi/g.

*Crack in exposed cast iron IWL under Los Alamos Canyon bridge (27+19 to 27+74).*
